SERVICE INFORMATION BULLETIN

Bulletin: 01-03-01

Subject: WATER-IN-FUEL SWITCH

Models Affected: ALL

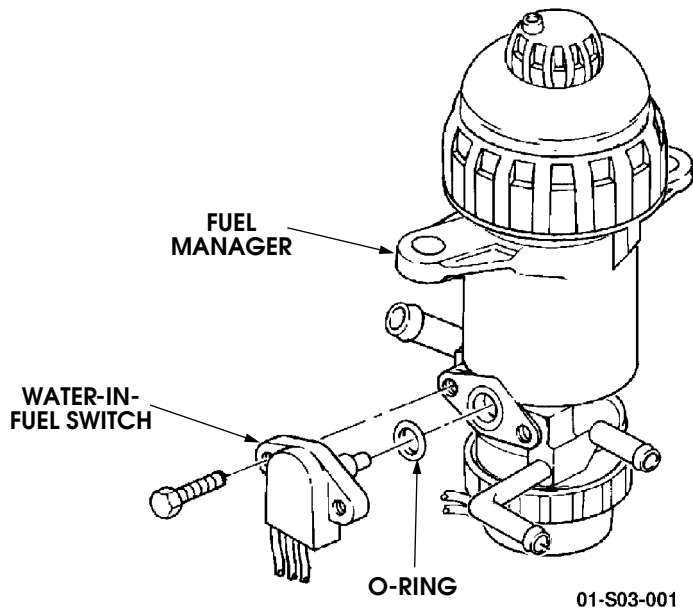
During vehicle operation, the “drain filter” light may illuminate when subsequent investigation reveals no water is present in the fuel manager. The condition is caused by a leak in the water-in-fuel switch potting which allows moisture to enter the switch from the outside and activate the drain filter light when there is no water present in the fuel.

Figure 1: Water-in-fuel switch replacement.

- If water is present in the fuel, drain and clean the fuel system and replenish with fresh fuel.
- If water is not present in the fuel, change the water-in-fuel switch located in the side of the fuel manager (See Figure 1). Do not change the fuel manager for a water-in-fuel switch problem.
