# Low-Cost Ways To Fix Common Control Head Problems In Chevy-GMC Trucks and C/K Pickups

This article covers two of the most common A/C repairs needed on some very popular Chevy and GMC trucks: 1) erratic or no airflow through the vents, and 2) a compressor that is reluctant to turn off.

## Low-cost way to “fix” a common A/C problem on: 1995 and 1996-99 Chevy and GMC light trucks

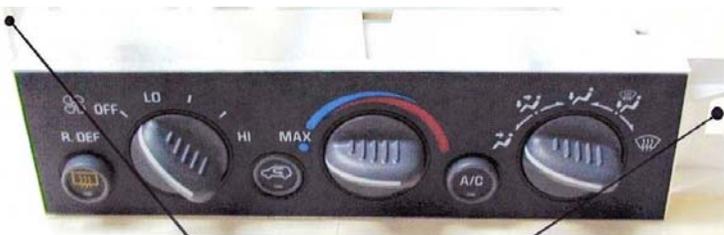
Photo 1. Clips holding in the Control Head

3. With the molding out of the way, insert a flat screwdriver on the control head plastic retainers A and B (Photo 1).

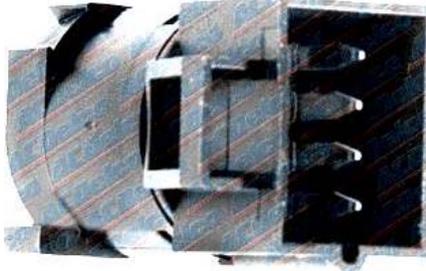
**Photo 8. Delco Blower Control Switch #15-72275**

So you know, in case you're ever told you need to cough up an extra \$150 - \$200 for a new control head, the problem is due to a faulty blower control switch, not the whole head. This blower control switch is sold as a separate service item and is fairly easy to replace. The control knob, a retainer with a screw, and two plastic hooks keep it in place. Unlike the erratic airflow problem, #1, this condition also affects the 1995 model year.

1995 - 1999 C/K trucks use the same switch. Delco part is #15-72275. See Photo 8 and keep this article handy; you never know when you'll need it.
