SERVICE INFORMATION BULLETIN

Bulletin: 98-11-03

Subject: MAIN HVAC DRAIN TUBE DUCKBILL (KAZOO)

Models Affected: VEHICLES WITH VIN 178369 AND ABOVE

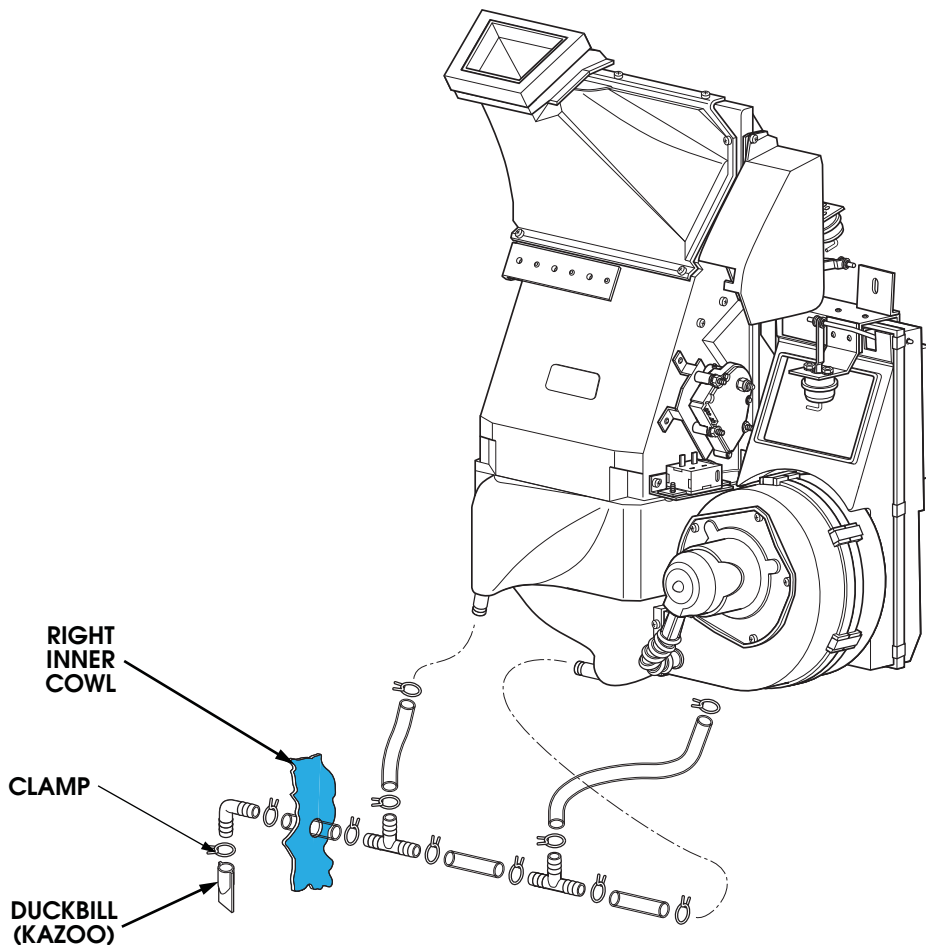
Figure 1: Drain Tube Kazoo Location.

Starting with VIN 178369, vehicles are being built without the kazoo and retaining clamp on the drain tube of the main HVAC unit (See Figure 1). The kazoo has been removed to eliminate the possibility of moisture backing up into the HVAC unit. Leave the drain tube open and do not install a kazoo.
